# **INDOOR AIR QUALITY ASSESSMENT**

**Amesbury Town Hall  
86 Friend Street  
Amesbury, Massachusetts**

Prepared by:  
Massachusetts Department of Public Health  
Bureau of Environmental Health Assessment  
July, 2001

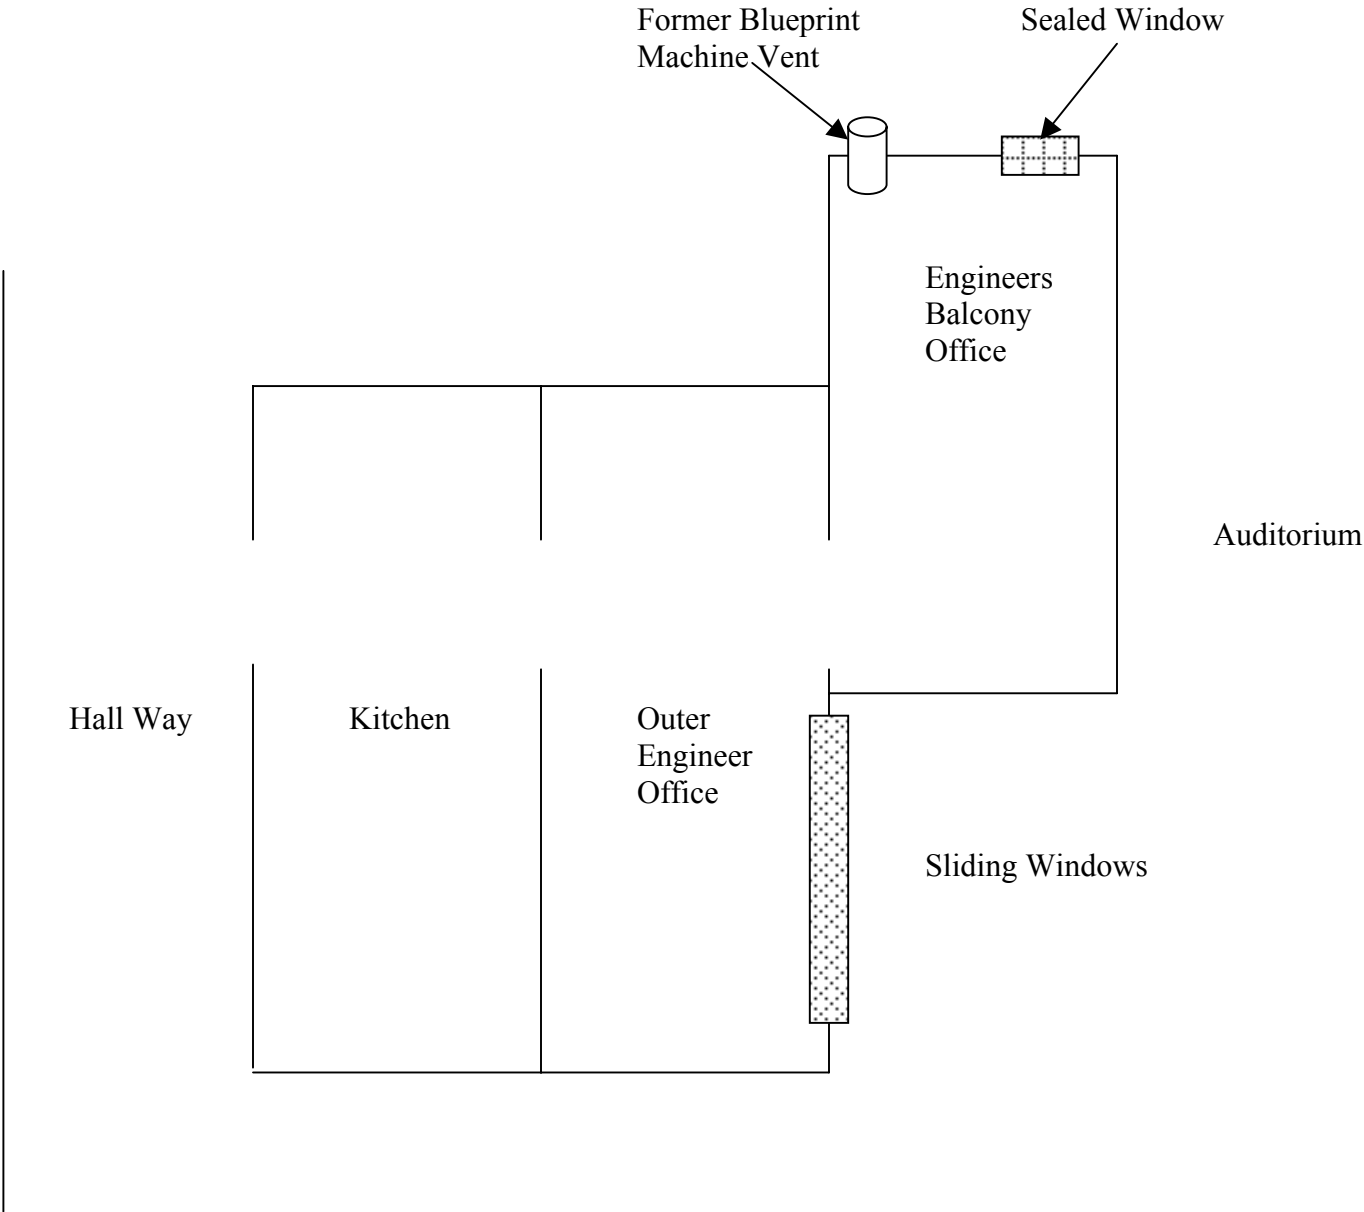
Figure 1

Of note is the configuration of the engineer's offices that were converted from auditorium balcony space. The balcony was enclosed by the installation of gypsum wallboard and sliding windows (see Figure 1, Picture 1). The engineer's office window

cannot be opened due to the installation of a window-mounted air conditioner. The sealing of the window creates a cul-de-sac where air movement into these offices from the hallway would be limited if the sliding windows are closed.

5. Examine the feasibility of having a downspout/gutter system installed on the peaked roof building to direct water away from the alleyway.
6. To improve air movement in the converted balcony office space, consider opening the sliding glass windows and place a floor fan in the opening to eject air from these offices into the auditorium.

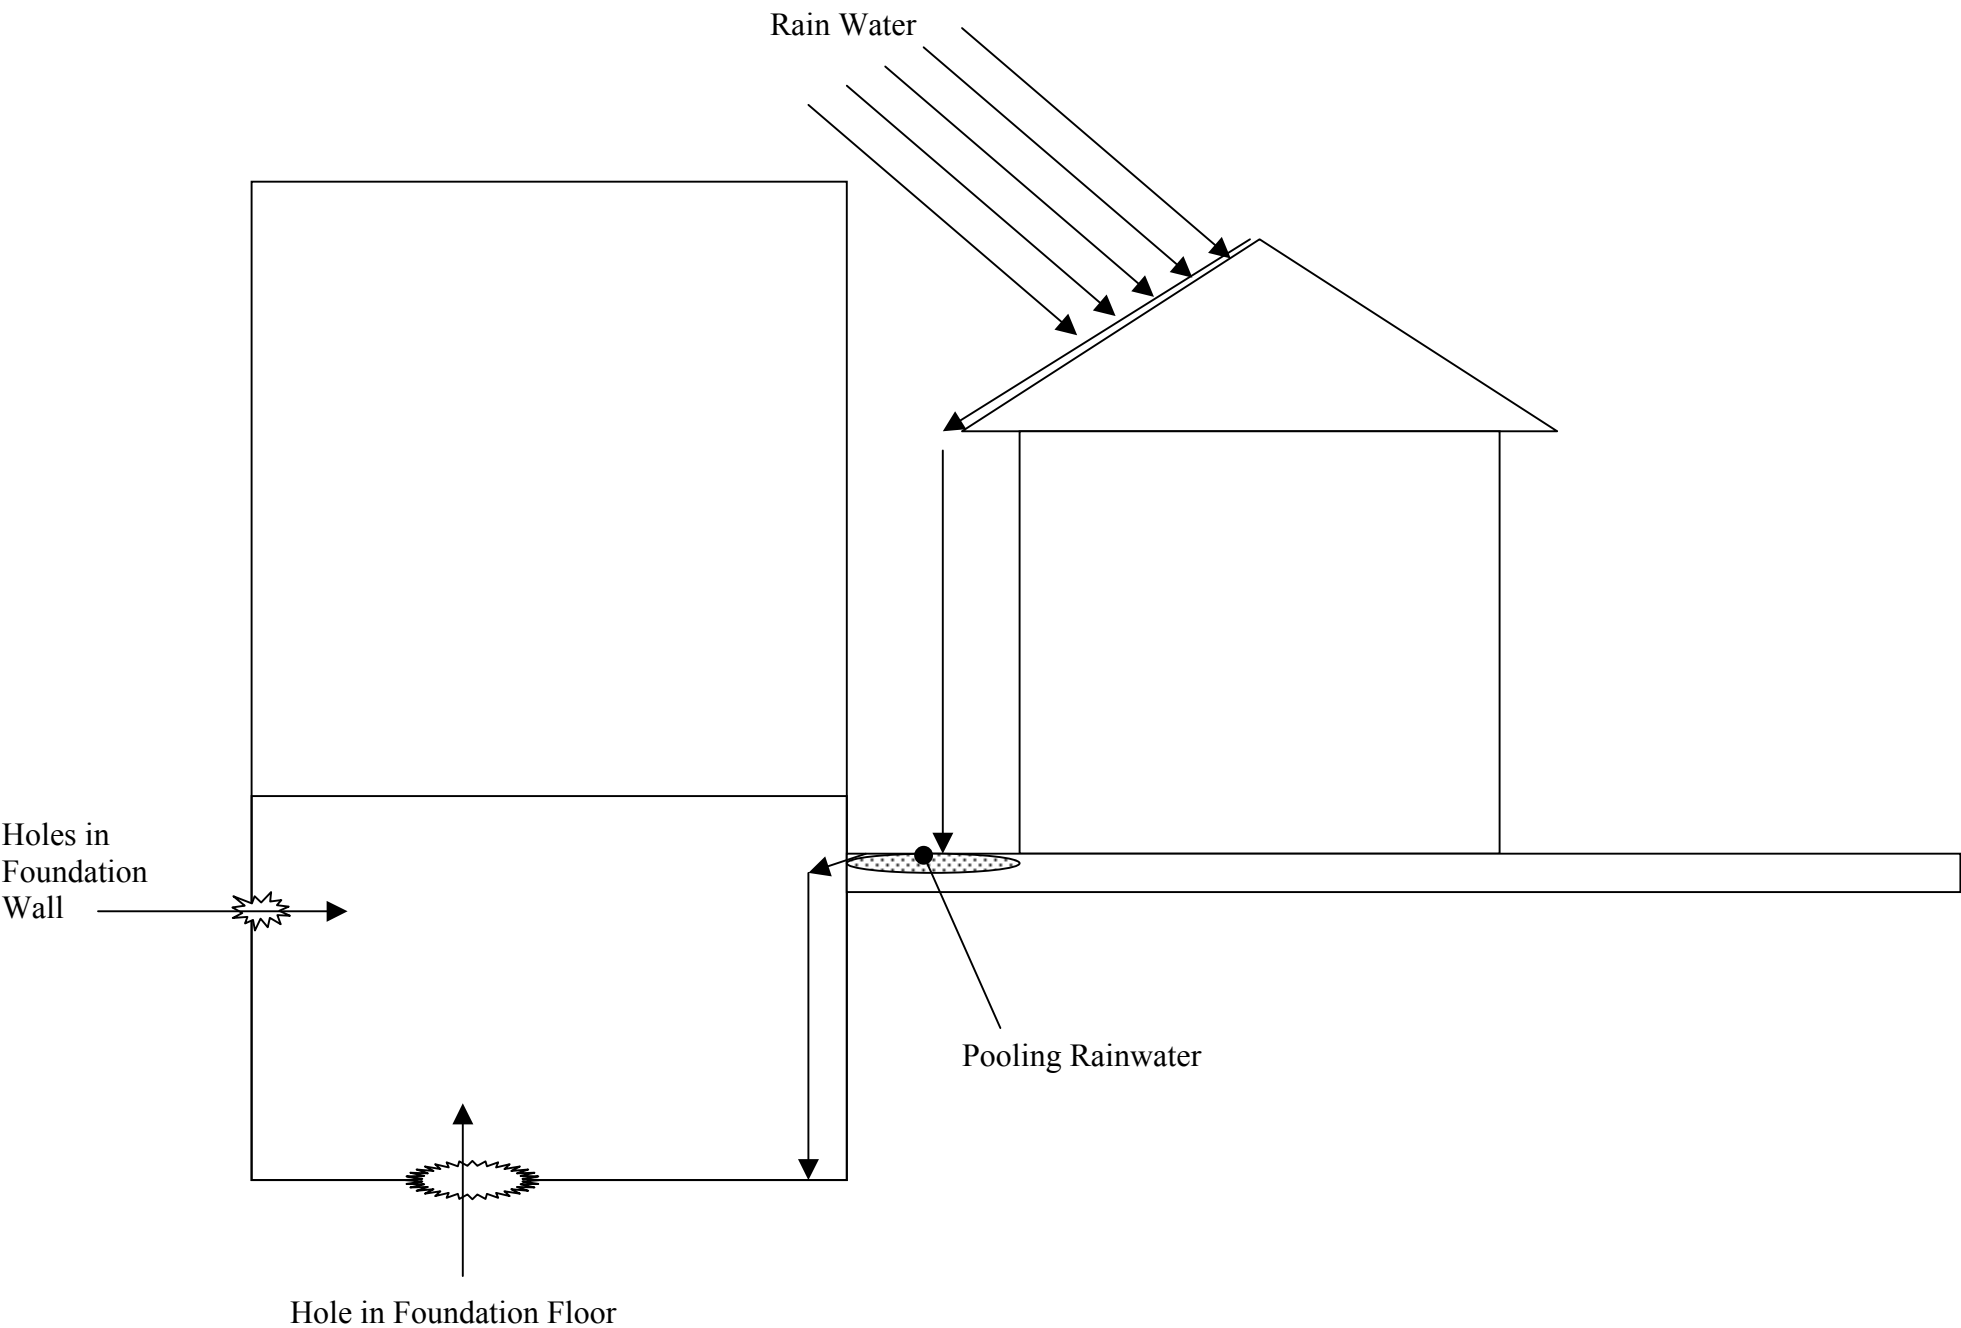
**Figure 2**

The increased relative humidity in the basement can be attributed to several sources on the exterior of the building (see Figure 2). The one major source of water penetrating into the basement appears to be water runoff from a peaked roof on a house immediately adjacent to the town hall (see Picture 6). The alleyway between the town hall and house is covered by cement (see Picture 7). The roof does not have a gutter/downspout system, which results in rainwater collecting on the ground between buildings. No drain appears to exist in the alleyway. Collected water in the alleyway may then penetrate into the basement. Confirming this moisture pathway is the presence of efflorescence along exterior walls in the restroom (see Picture 8). Efflorescence is a characteristic sign of water damage to brick and mortar, but it is not mold growth. As moisture penetrates and works its way through mortar around brick, water-soluble compounds in bricks and mortar dissolve, creating a solution. As the solution moves to the surface of the brick or mortar, the water evaporates, leaving behind white, powdery mineral deposits.

Means of Water and Its Vapor to Penetrate into Amesbury Town Hall

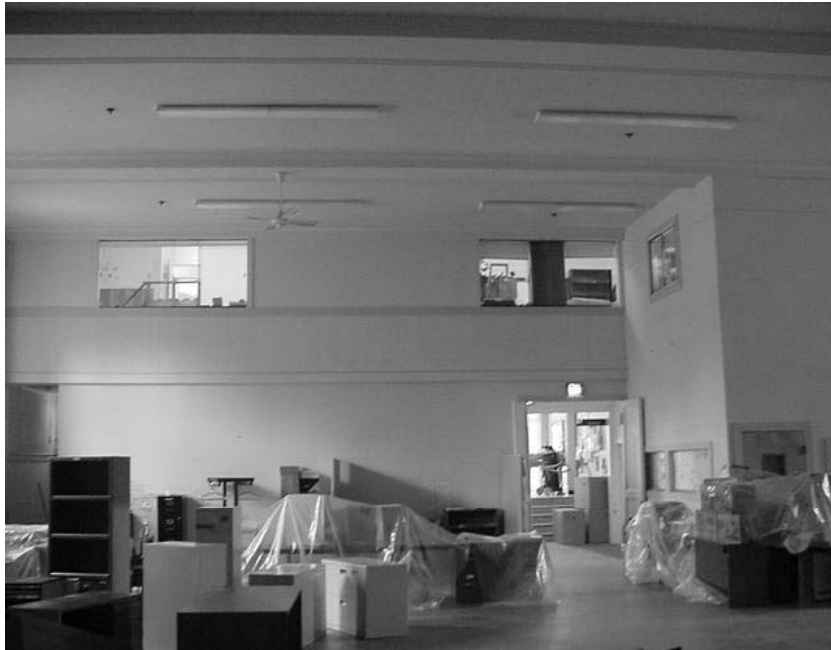
**Picture 1**

**Sliding Glass Windows in Engineer's Outer Office**

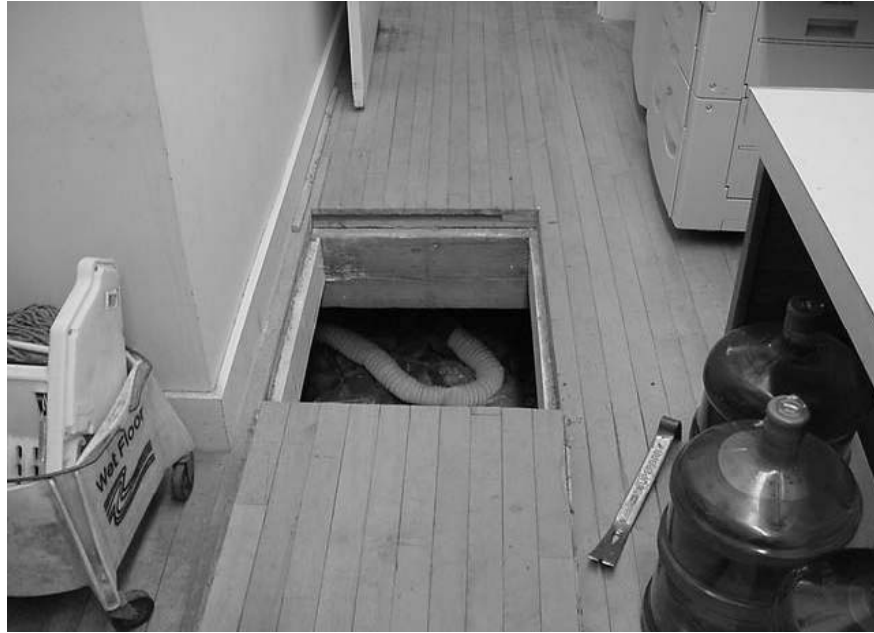
**Picture 2**

Some rest rooms have mechanical exhaust ventilation. The mechanical exhaust ventilation system in the second floor restroom is controlled by activating the light switch. Without active exhaust ventilation, rest room odors and moisture can penetrate into adjacent hallways and offices. With the lack of exhaust ventilation, pollutants that exist in the interior space can build up and remain inside the building, which can subsequently lead to indoor air complaints. Of note is the terminus of the handicap restroom vent, which ends in a cardboard box in the crawl space beneath the workroom (see Picture 2). This configuration can result in restroom odors penetrating into occupied space. With the restroom exhaust vent deactivated, cold crawlspace air can travel backwards up the flexible duct and into the restroom.

**Handicap Restroom Vent in Crawl Space**

13. Examine all restroom exhaust vents to ensure that ductwork exits the building. Once ductwork is directing exhaust air outdoors, operate exhaust vents during business hours. Consider installing restroom exhaust vent fan controls that are independent of light switches.

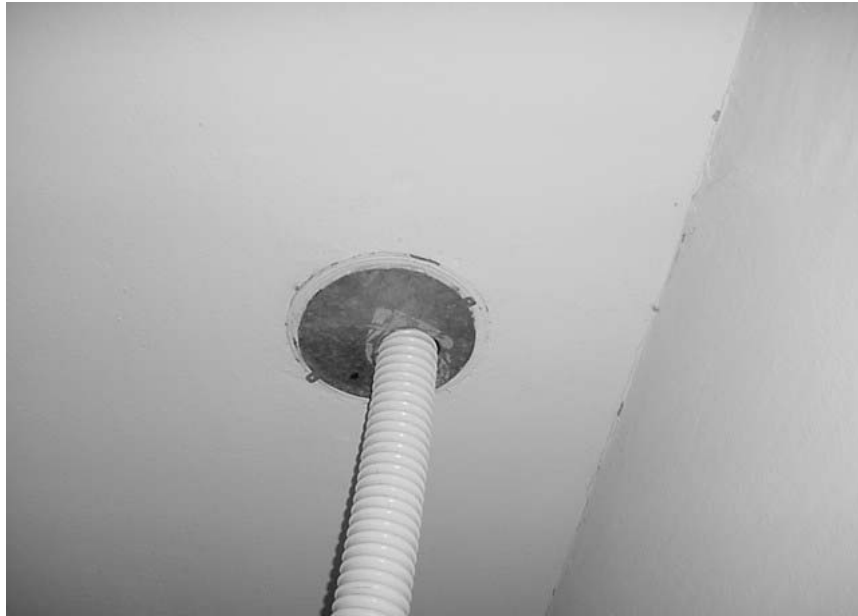
**Picture 3**

An exhaust vent exists in the ceiling of the kitchen area located outside the engineer's offices. The kitchen ceiling was installed with a similar type of flexible hose to that of the duct in the crawlspace. This flexible duct was in three pieces, originally joined with tape (see Pictures 3 through 5). If the vent is operated, air is injected into the ceiling plenum.

**Flexible Duct Section above Engineer's Office**

12. Remove disconnected ductwork above the second floor kitchen and outer engineer's office. Either replace the flexible duct with a single continuous piece or consider sealing this system to prevent air backflow from the roof.

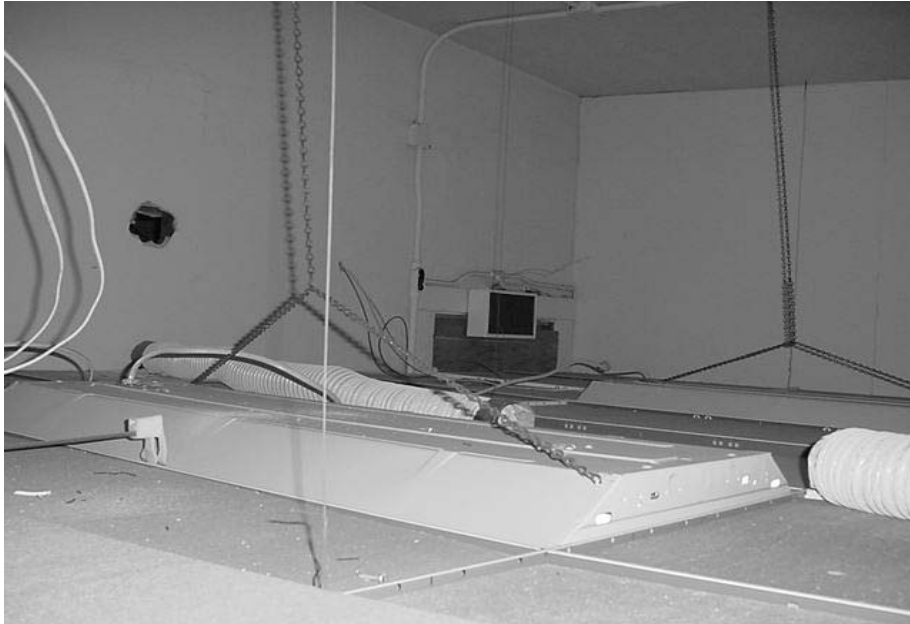
**Picture 4**

**Flexible Duct Section in Wall Separating Engineer's Office from Kitchen. Note Duct Tape**

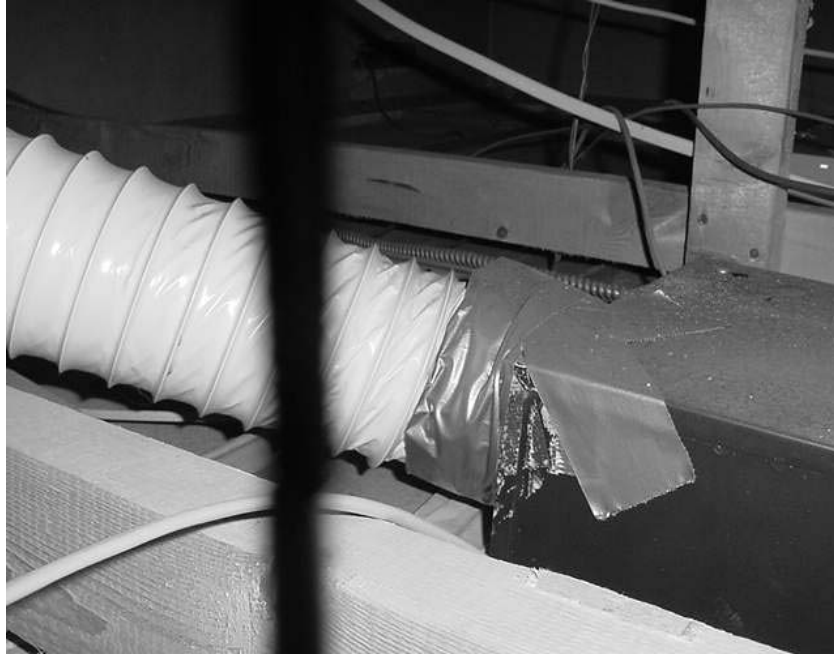
**Picture 5**

**Flexible Duct Section Above Kitchen Ceiling**

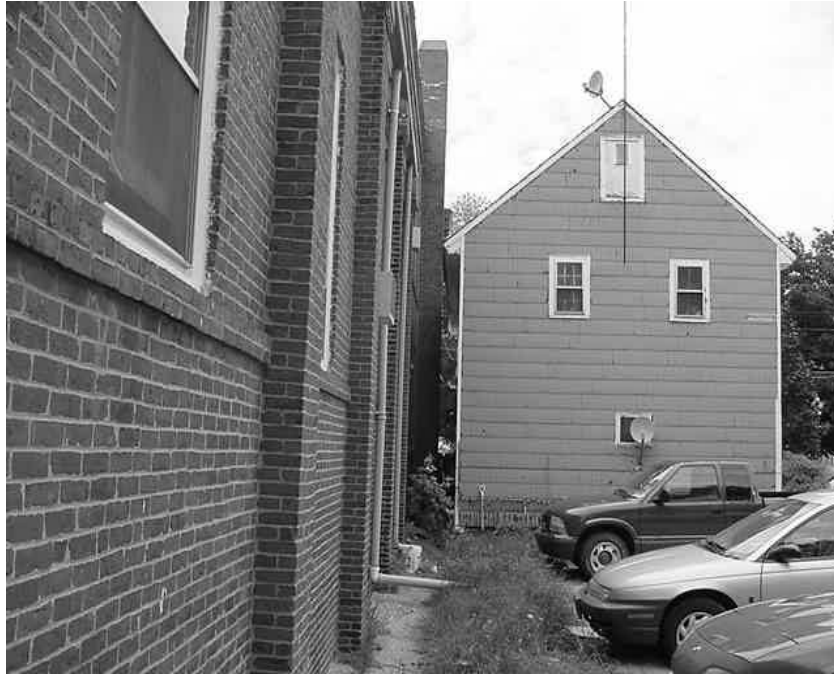
**Picture 6**

**A Peaked Roof On A House Immediately Adjacent To the Town Hall**

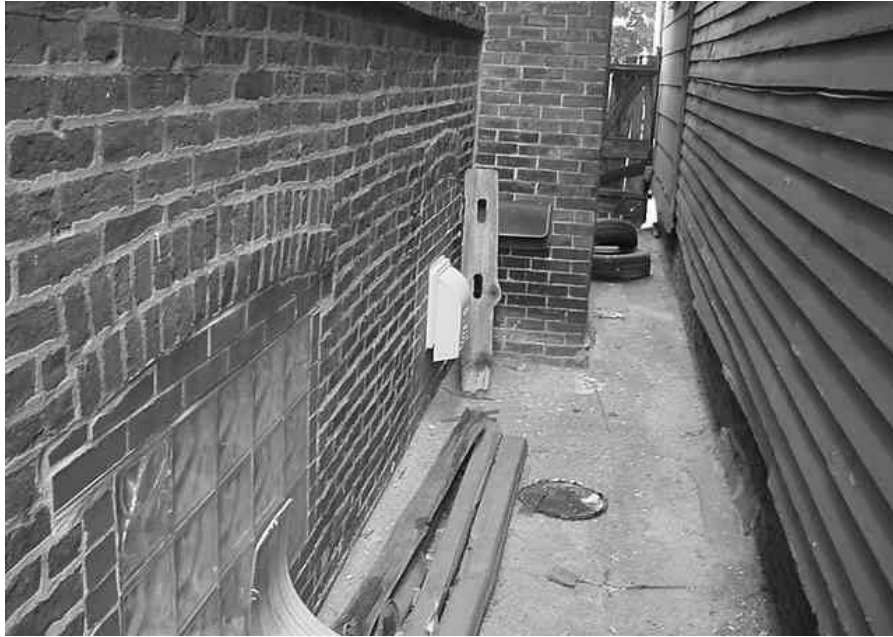
**Picture 7**

Another major source of collecting water in the alley is the configuration of the town hall roof. As reported by town hall employees, the roof over the front section of the building is flat and sloped towards the alleyway side of the building. This configuration allows for water to run down the east wall of the building. Water exposure to the east wall is confirmed by several conditions.

**Alleyway between the Town Hall and House**

3. Continue with plans to examine the feasibility of repairing the roof and improving drainage to prevent east wall water damage.
4. Seal the alleyway cement/exterior wall junction with an appropriate sealing compound.

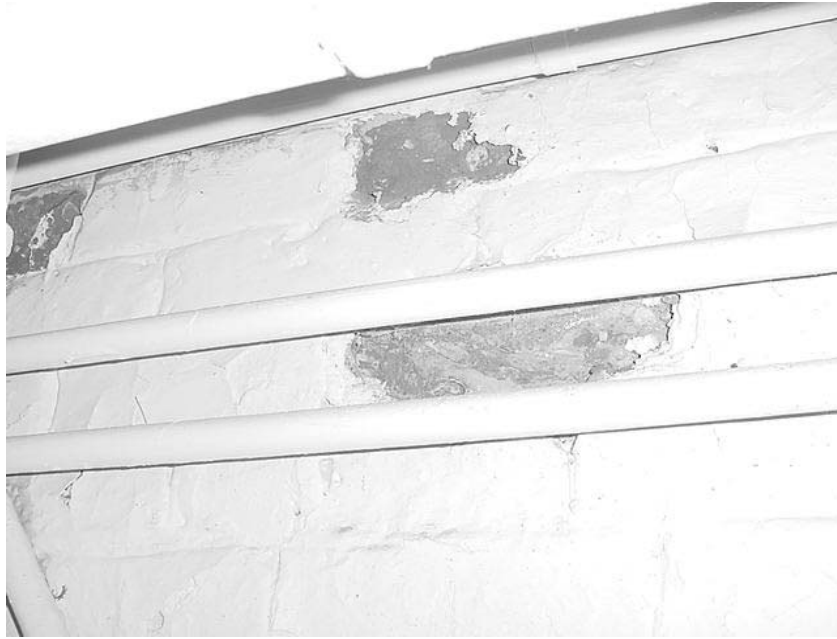
**Picture 8**

**Efflorescence along Exterior Walls in the Restroom**

18. Consider removing below grade carpeting and replacing it with a non-porous surface.
19. Consider removing paint from the basement restroom wall to prevent brick damage and possible mold growth in paint.

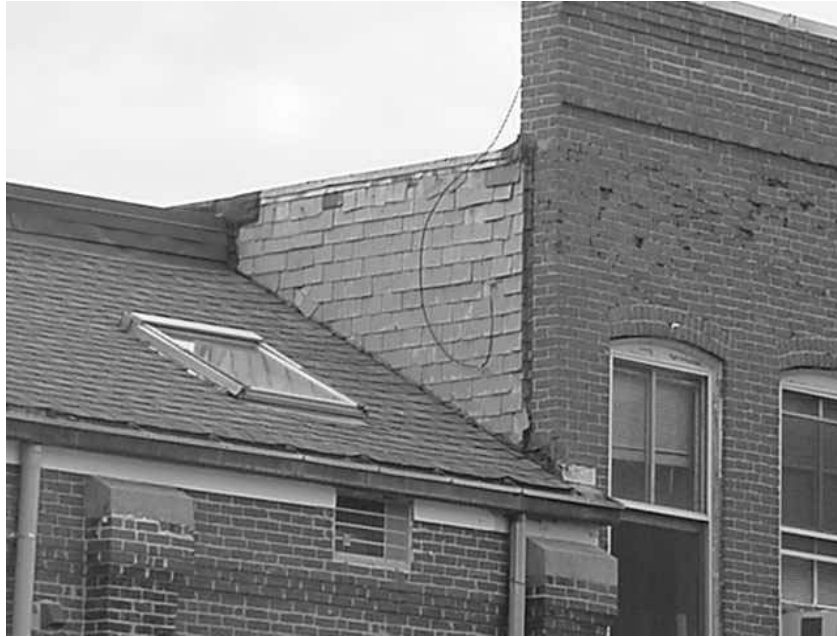
**Picture 9**

First, masonry near the roof is damaged (see Picture 9) reportedly from roof-water run off. Brick is damaged to the point where a plant was seen growing from the

**Masonry near the Roof Is Damaged**

8. Once the roof is repaired, repair water damaged plaster and examine the feasibility of repointing brickwork and repairing window frames along the east wall.

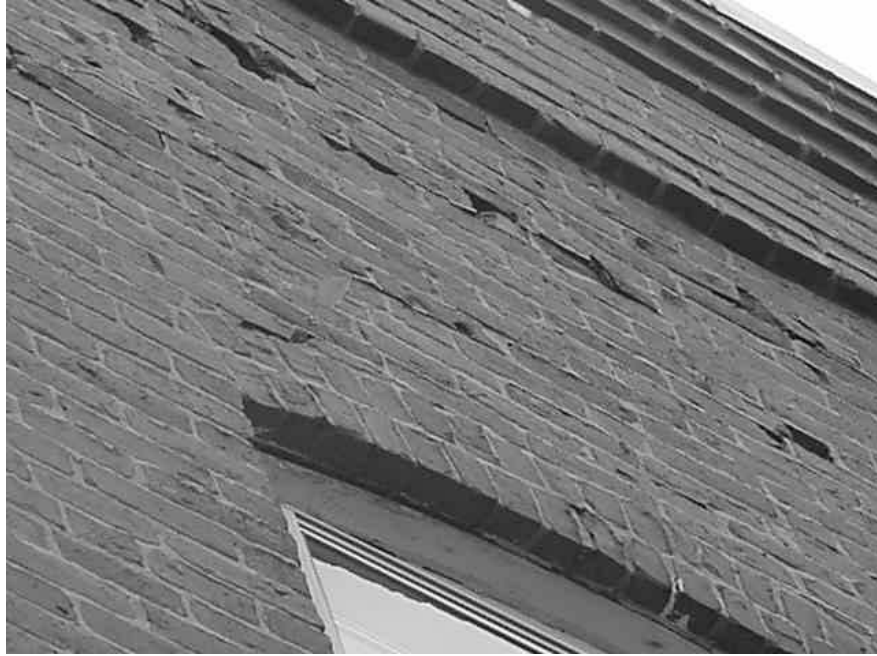
**Picture 10**

brickwork (see Picture 10). Damaged exterior brick can lead to increased water penetration that can damage window frames and interior plaster.

**Plant Was Seen Growing From the Brickwork**

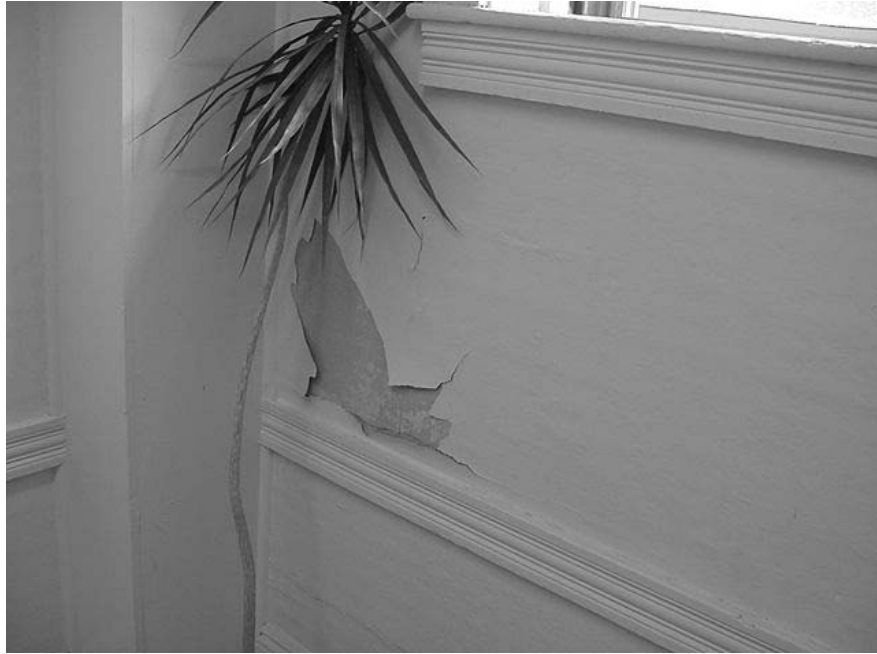
**Picture 11**

Secondly, masonry around windows appeared to be eroded from significant water damage. This erosion may account for possible water penetration into the wall cavities on the town hall's east wall. Confirming this assumption is water damage to wall plaster in and around windows in the east wall stairwell (see Picture 11). If water has penetrated into the wall cavity, interior wall materials may have become repeatedly moistened by rain. Wall materials, such as paneling, can serve as a mold growth medium. Wall plaster is not a good mold growth media, however water trapped behind wallpaper or paint coats can become mold growth media. Thirdly, the seam between the alley cement and east exterior wall is open, making this area prone to water penetration from rainwater runoff.

**Water Damage to Wall Plaster in And Around Windows in the East Wall Stairwell**

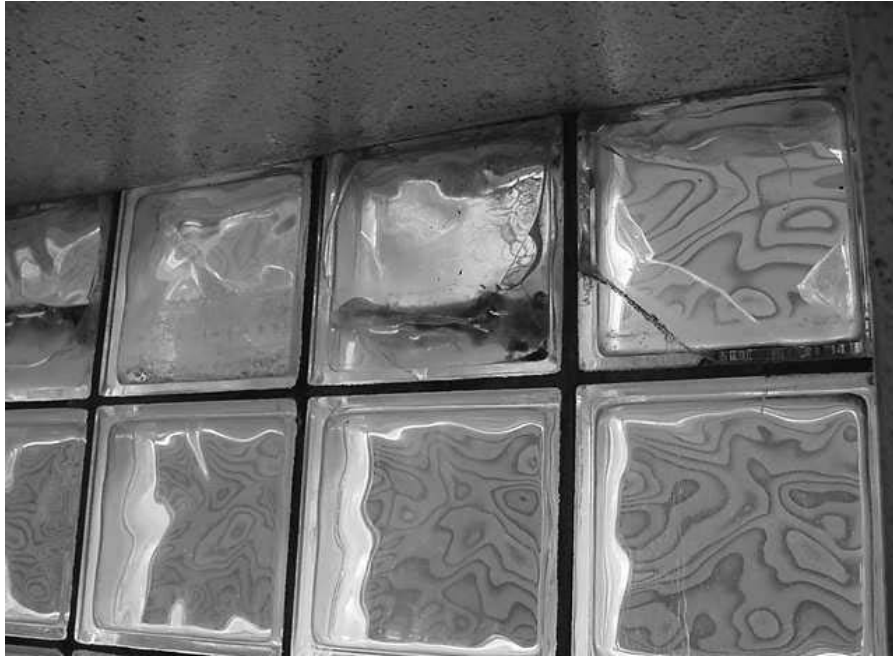
**Picture 12**

Lastly cracked block windows in the ladies restroom are filled with water and have algae growth (see Picture 12). Since this window is on the first floor in a sheltered area, the most likely source of rainwater that could fill these glass blocks would be rainwater running down the side of the east wall. All of these conditions indicate that significant water exposure and penetration exists along the east side of this building. Once moisture enters a wall cavity, microbial growth may occur in building materials and/or water may penetrate into occupied areas.

**Cracked Block Windows In The Ladies Restroom Are Filled With Water And Have Alga Growth**

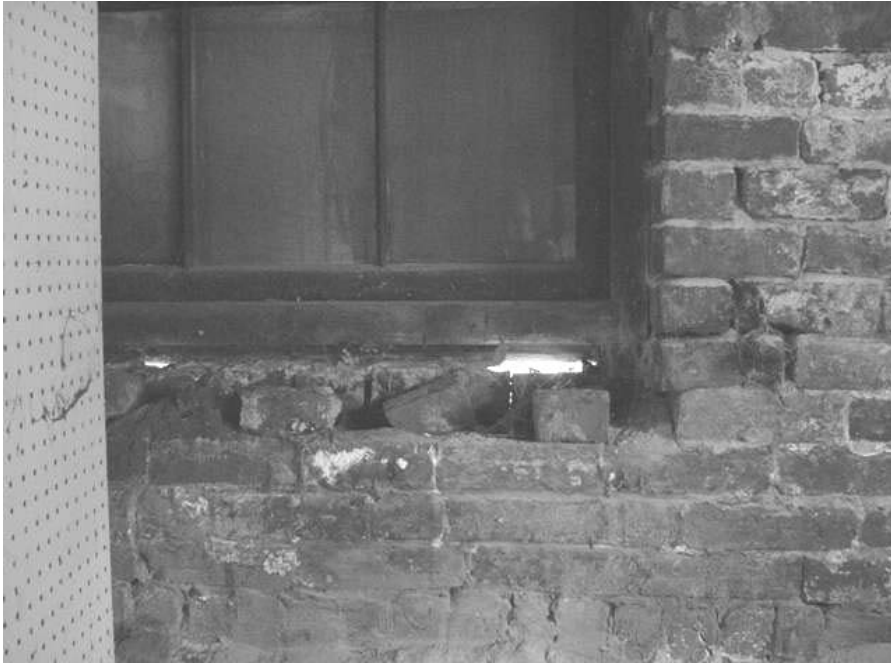
**Picture 13**

Other sources of relative humidity in the basement are exterior holes in the foundation, sills, steps and exterior wall (see Picture 13 through 15). Uncontrolled air penetration can result in moisture penetrating into the building; particularly through holes in the floor where utilities enter the building. With increased water penetration and no mechanical ventilation system, water vapor and accumulation in the basement appears to

**Holes In Brickwork of Exterior Wall**

9. Seal the hole around former blueprint machine exhaust vent in the inner engineer's office.
10. Seal the holes in the foundation floor, walls, sills, stairs and exterior wall to reduce moisture penetration.

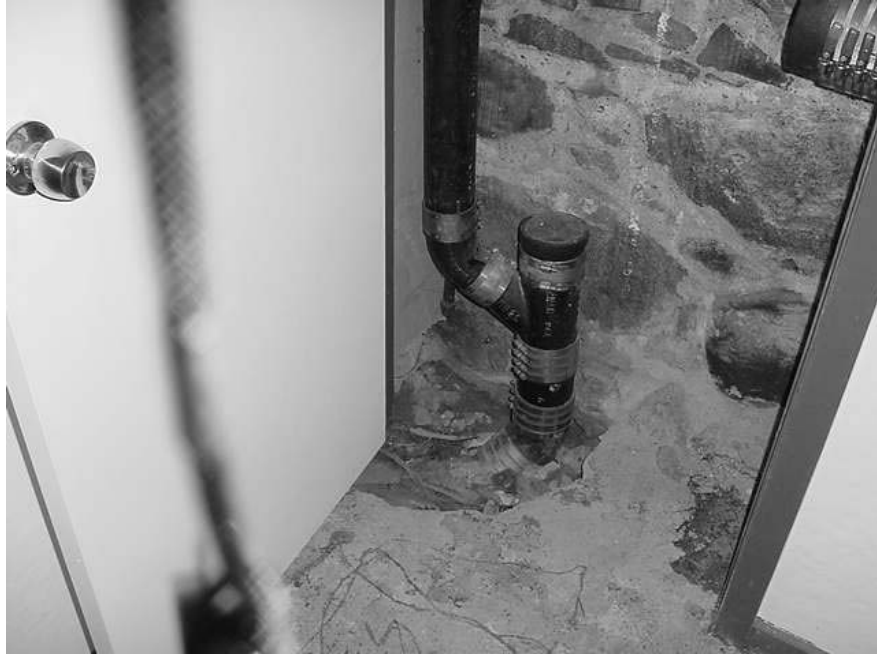
**Picture 14**

**Drainpipe Through Foundation Floor In Basement, Located Behind A Door**

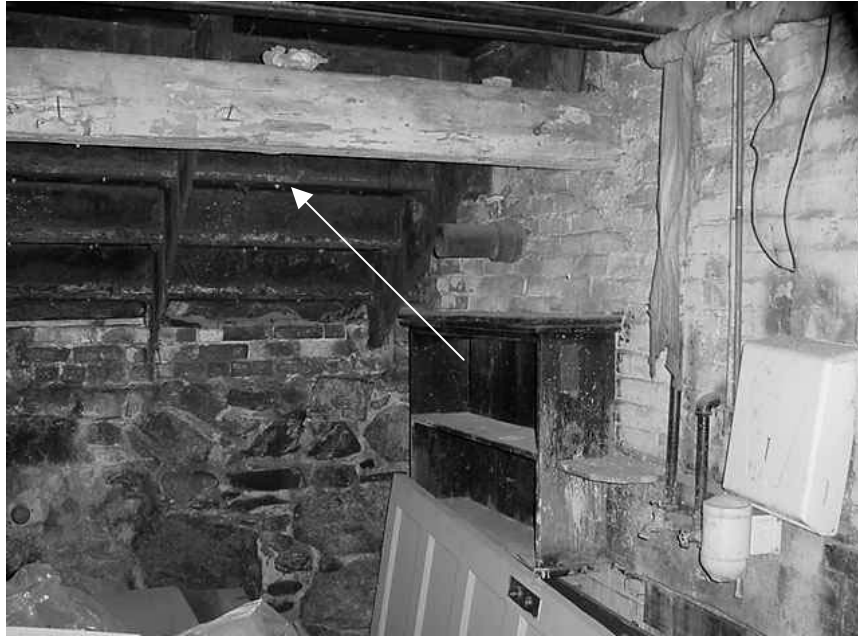
**Picture 15**

**Holes In Front Stairwell to the Outdoors**

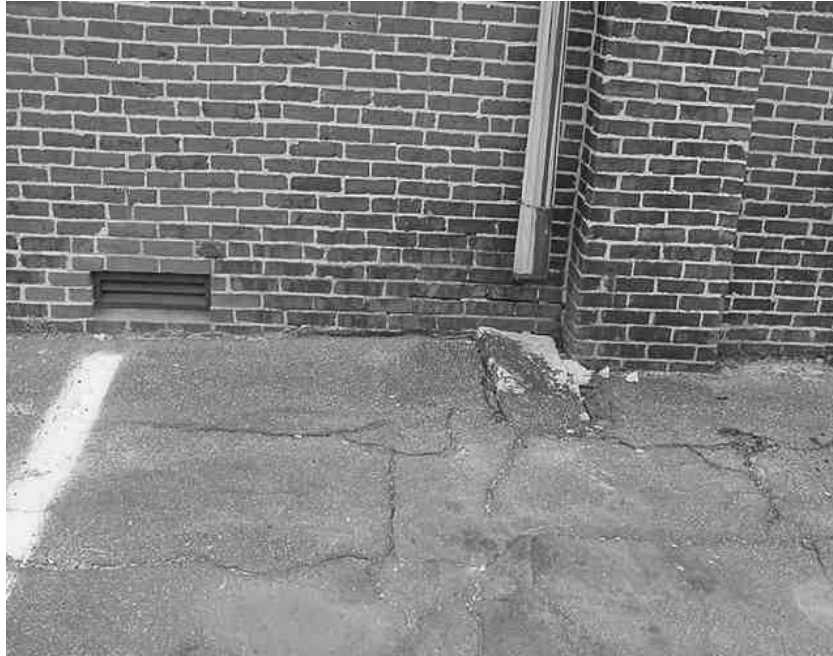
**Picture 16**

Means for moisture to penetrate into the auditorium crawl space also exists. Opportunities for water penetration through the building envelope are created along the exterior wall/tarmac junction. Several downspouts exist which empty above the wall/tarmac junction, resulting in splashing rainwater in this area (see Picture 16). Plants were noted growing in the junction between the exterior wall and the tarmac (see Picture 17), which can collect water that accumulates in this area. Freezing and thawing of gathered water can result in damage to the exterior wall, which can result in water penetration into the building.

**Several Downspouts Exist And Empty Above The Wall/Tarmac Junction, Which Can Result Is Splashing Rainwater To Accumulate In This Junction**

7. Remove plants from the wall/tarmac junction around the perimeter of the building. Reconfigure downspouts to direct rainwater from the base of the building. Seal the wall/tarmac junction with an appropriate sealer.

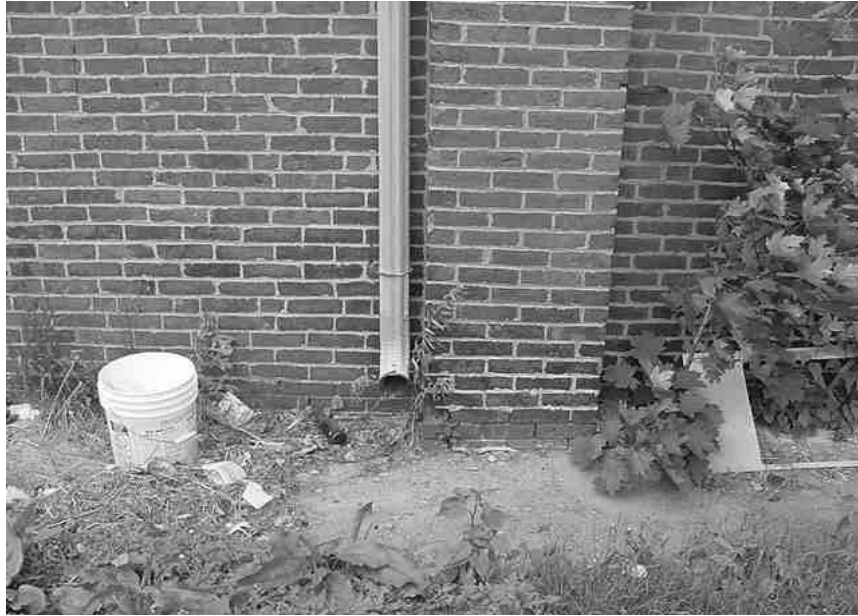
**Picture 17**

**Plants Were Noted Growing In the Junction between The Exterior Wall And The Tarmac**

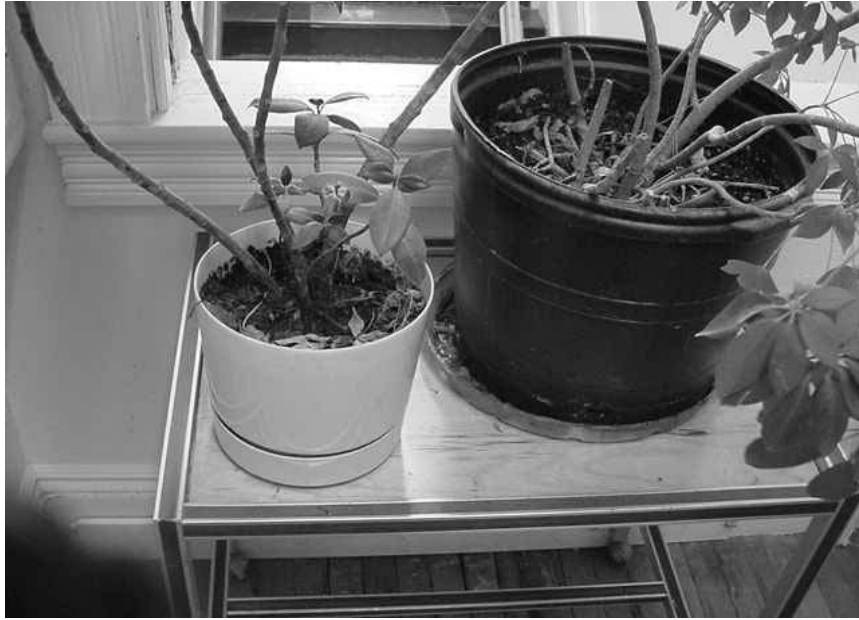
**Picture 18**

Several areas contained plants (see Picture 18). Moistened plant soil, drip pans and standing water can serve as a source of mold growth. Plants should be equipped with drip pans and over watering should be avoided.

**Several Areas Contained Plants**

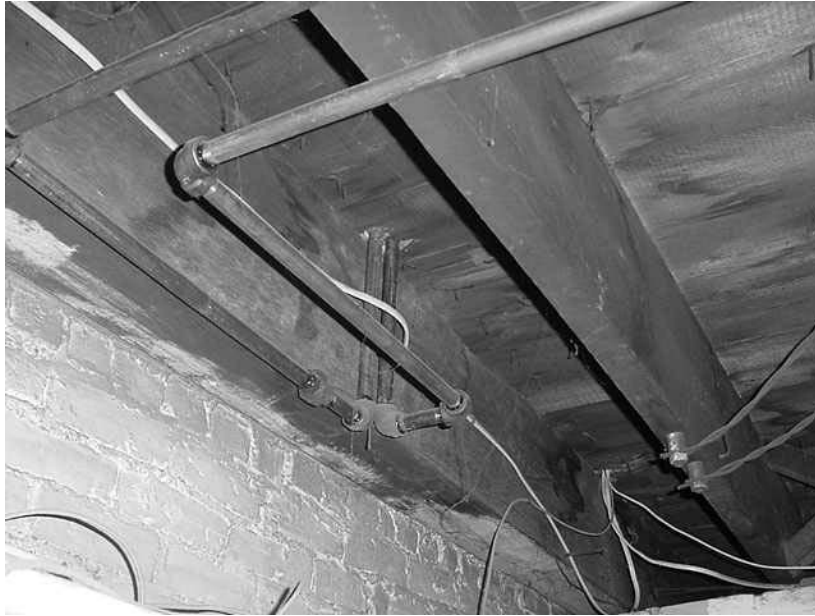
**Picture 19**

The building has undergone periodic renovations over the past several years. The building was retrofitted with a computer network. Holes were noted around pipes connected to the heating system (see Picture 19) and plumbing (see Picture 20). In the town clerk's storage room, a sink system was removed and the holes remaining in the floor were covered with cardboard (see Picture 21). In addition, the installation of computer network cables necessitated the drilling of numerous holes in interior walls and floors (see Picture 22). The drilling of these holes has created plaster dust as well as a means for pollutants from one room to penetrate into an adjacent room. In addition, materials within the wall cavities now have a pathway into occupied space. As noted in the ATC report, any hole or space in the interior of offices along the exterior wall could serve as a pathway for wall cavity air and pollutants to penetrate into the occupied space. As an example, the engineer's office has an exterior wall penetration that formerly served as an exhaust vent for a blueprint machine (see Picture 23). This wall penetration can allow for wall cavity air to migrate into the engineer's office. Seams in walls/floors and ceiling, light switches, electrical outlets and seams in or around window frames in the internal east wall offices can all serve as pathways for pollutant migration as well. Since no mechanical exhaust system exists in the building, pollutants that penetrate into the

office space can tend to accumulate. Elimination of pathways of potential wall cavity pollutants need to be identified and sealed.

**Holes For Pipes Connected to the Heating System**

15. Render the access door to the auditorium attic crawl space airtight with weather-stripping.
16. Seal holes in the floors, walls and ceilings for pipes and cables to prevent infiltration of pollutants from wall cavities.

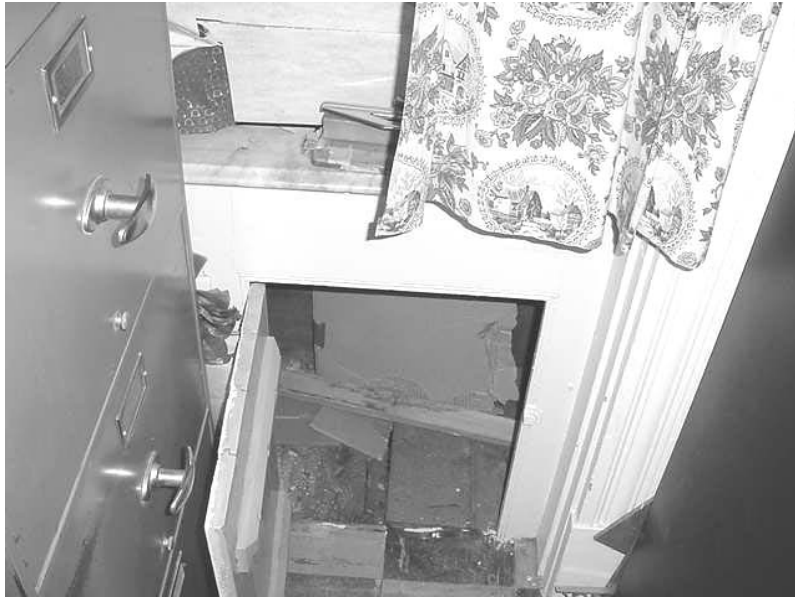
**Picture 21**

**Holes Remaining in the Floor Were Covered With Cardboard**

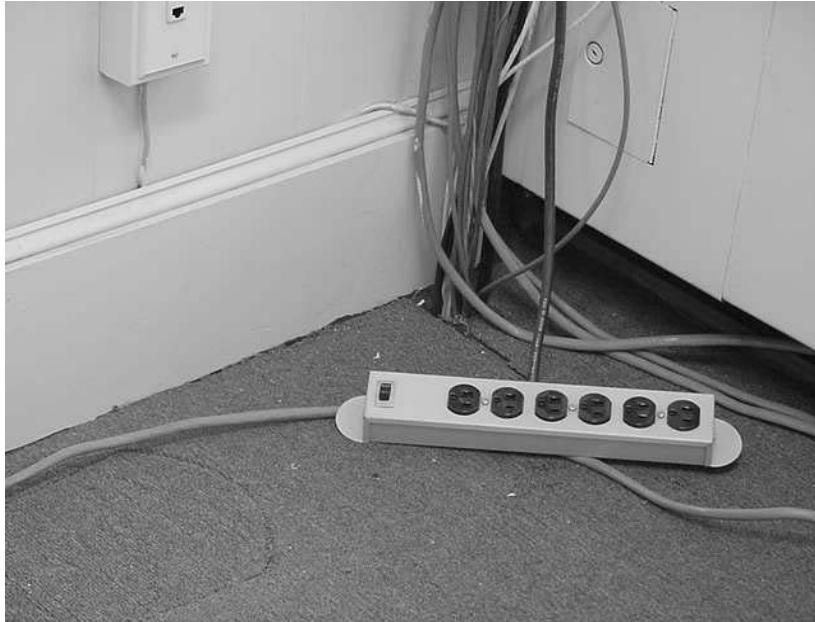
**Picture 22**

**Computer Network Cables Necessitated the Drilling of Numerous Holes in Interior Walls and Floors**

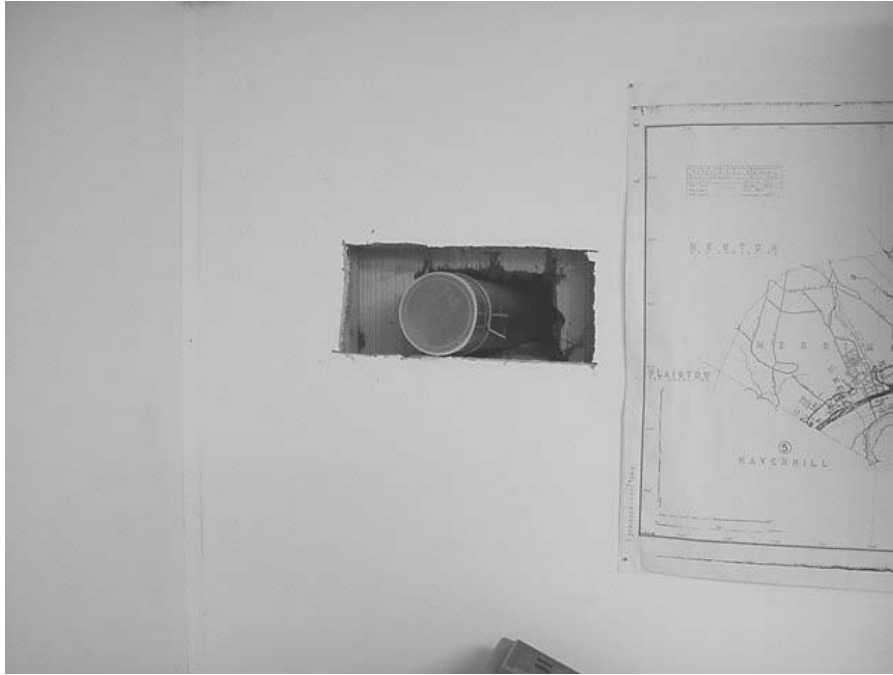
**Picture 23**

**Exterior Wall Penetration That Formerly Served as an Exhaust Vent for a  
Blueprint Machine**
